# BATTERY CERTIFICATE

AVILOO
BATTERY DIAGNOSTICS

**BRAND:** BYD
**MODEL:** Seal - 82,56 kWh

**MILEAGE:** 42,316 km
**VIN:** LGXCF6CD4R2038414
**DATE AND TIME:**
16/10/2026, 14:54

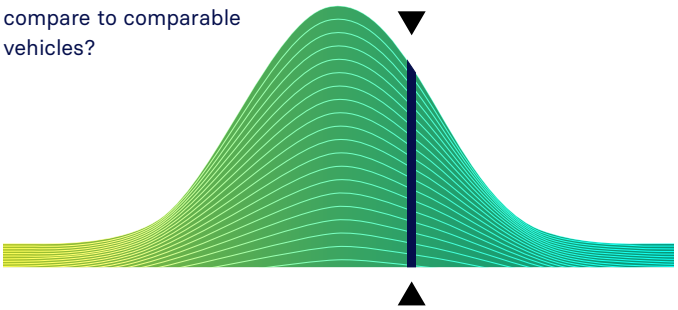
**BENCHMARKING**
How does your vehicle compare to comparable vehicles?

below average | average | above average
